BASHAN LAKE DAM
CT 00354

PHASE I INSPECTION REPORT
NATIONAL DAM INSPECTION PROGRAM

FEBRUARY 1979

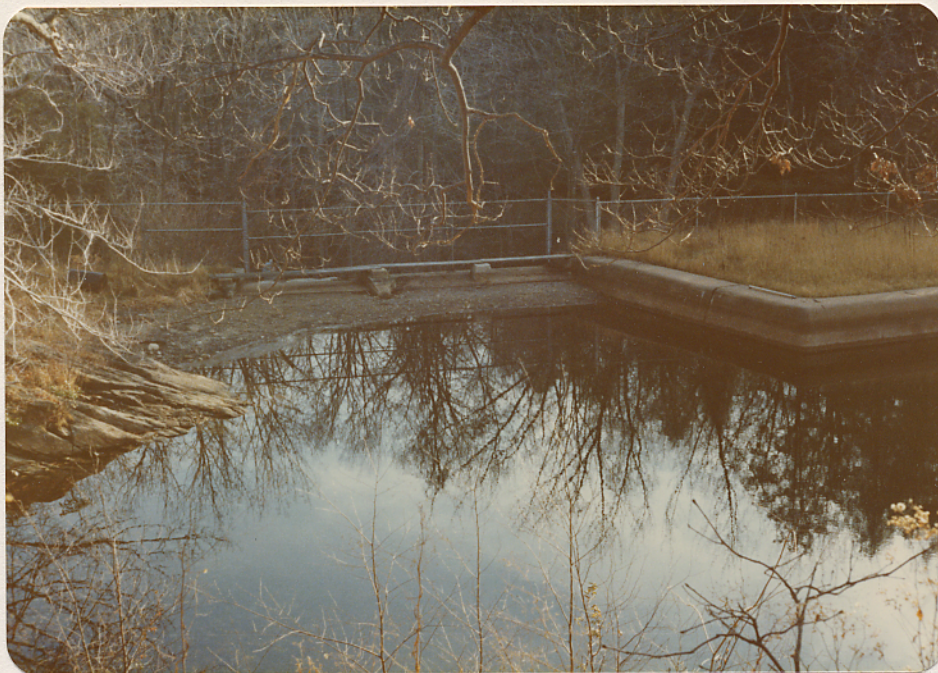
At the time of our initial site visit (December 7, 1978) the water level was about 3.4 feet below the top of the dam as shown in Photo 1. During subsequent visits to the site on January 15, 22 and 25, 1979, after considerable rainfall, the water level had risen to the spillway crest and then up to approximately 6 inches over the crest. The higher water levels have identified paths of flow under the concrete spillway cap. This flow discharges from between the granite blocks and from between the lowest granite block and natural rock exposure directly beneath the spillway crest. The condition of the downstream face in this area beneath the spillway crest must be described as only fair.

PHOTO NO.1 - Upstream view of spillway.

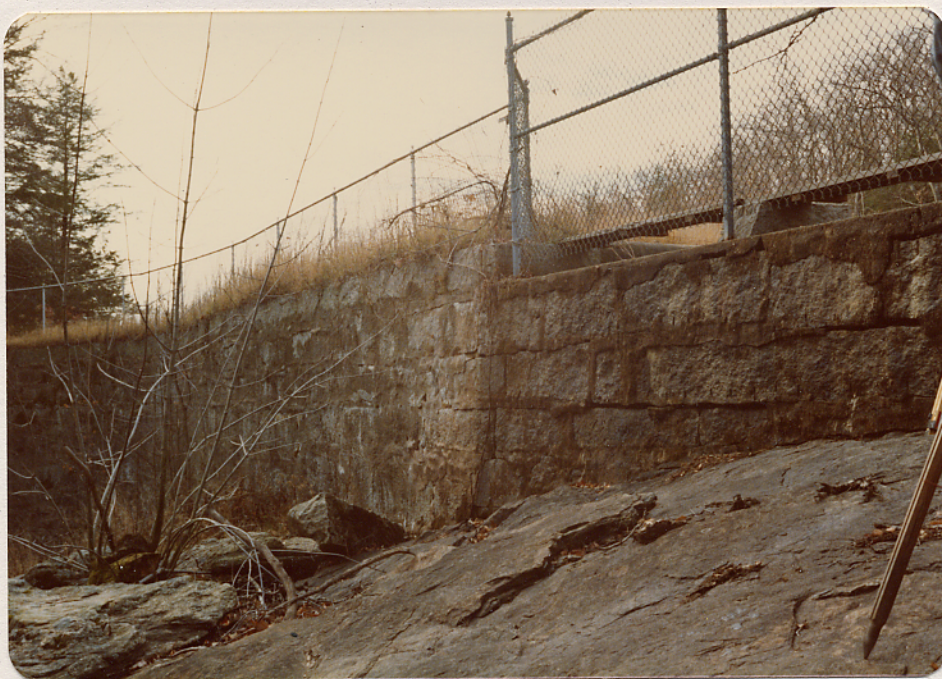
Due to the significant discharge of this area, there is a possibility that movement and initial failure of these spillway blocks could initiate further failures of the downstream granite block wall and possibly of the dam itself.

PHOTO NO.2 - Downstream view of spillway and downstream face of dam.

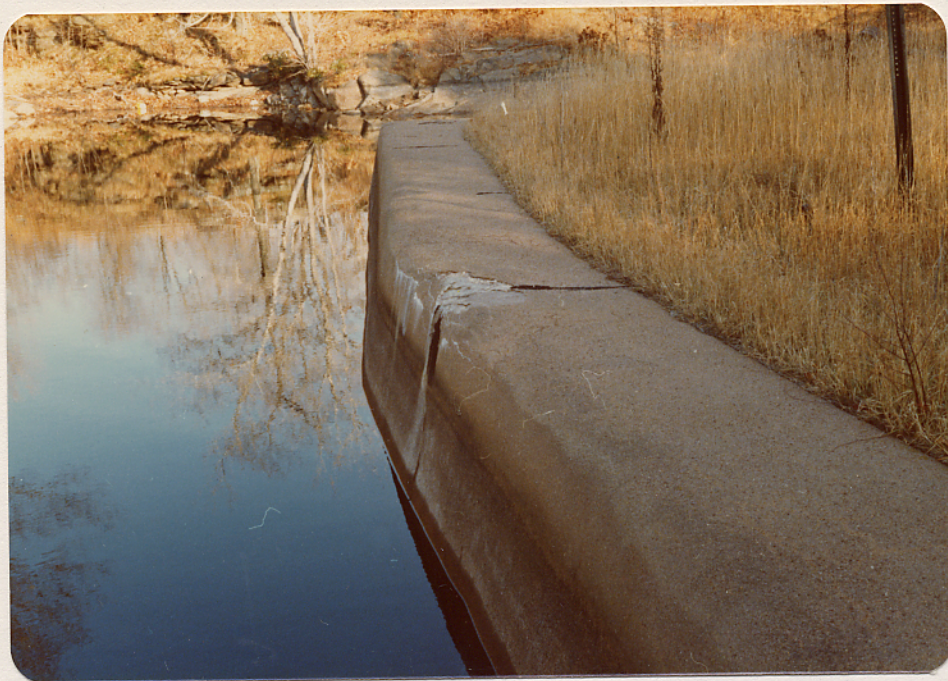
There are several vertical cracks in the concrete of the upstream face of the dam which extend across the top of the wall. Some of the cracks have been filled with a black tar-like material. All observed cracks are hairline with the exception of a crack with a width of about 1/2-in, located 25 ft to the left of the outlet works. This crack is shown in Photo 3 as viewed from the outlet works. An overhead view is shown in Photo 4. The crack could be seen to extend to the floor of the reservoir which is about 13 ft from the top of the dam. The depth of the crack was measured with an 1/8-in wide ruler near the crest where it had a maximum depth of 2 inches. Minor spalling of the concrete has occurred in the vicinity of this crack at the top of the wall. The soil surface at the crest of the dam in the vicinity of the crack was not significantly different than in other portions of the crest, nor was there seepage or cracking observed on the downstream face at the station of the upstream crack.

PHOTO NO.3 - Upstream face of dam with vertical cracking.

5. Cracks in the concrete of the upstream face should be repaired.

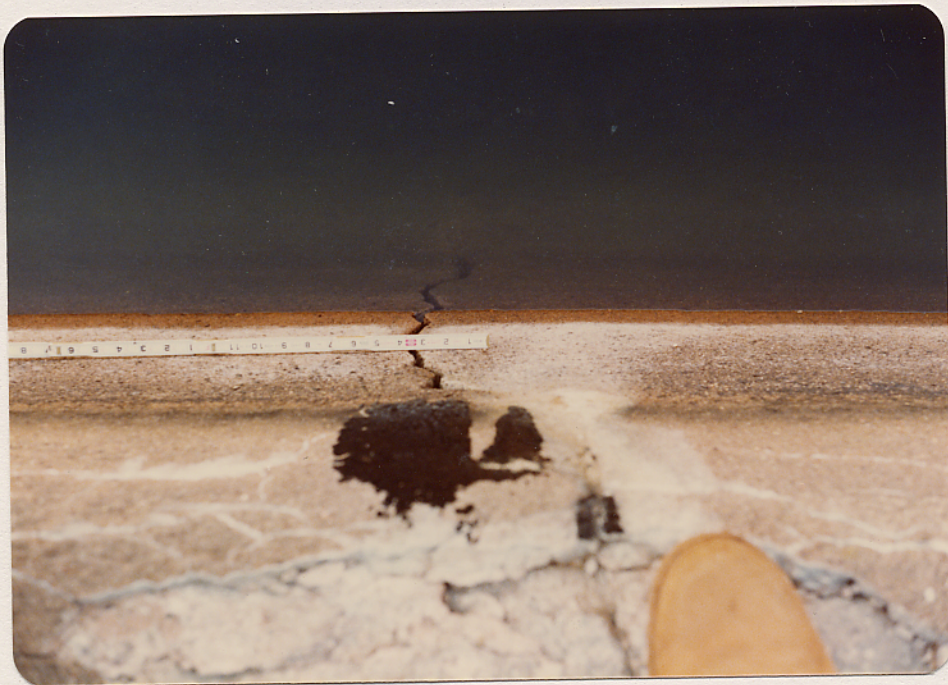
PHOTO NO.4 - Close-up view looking straight down at the above vertical cracking.

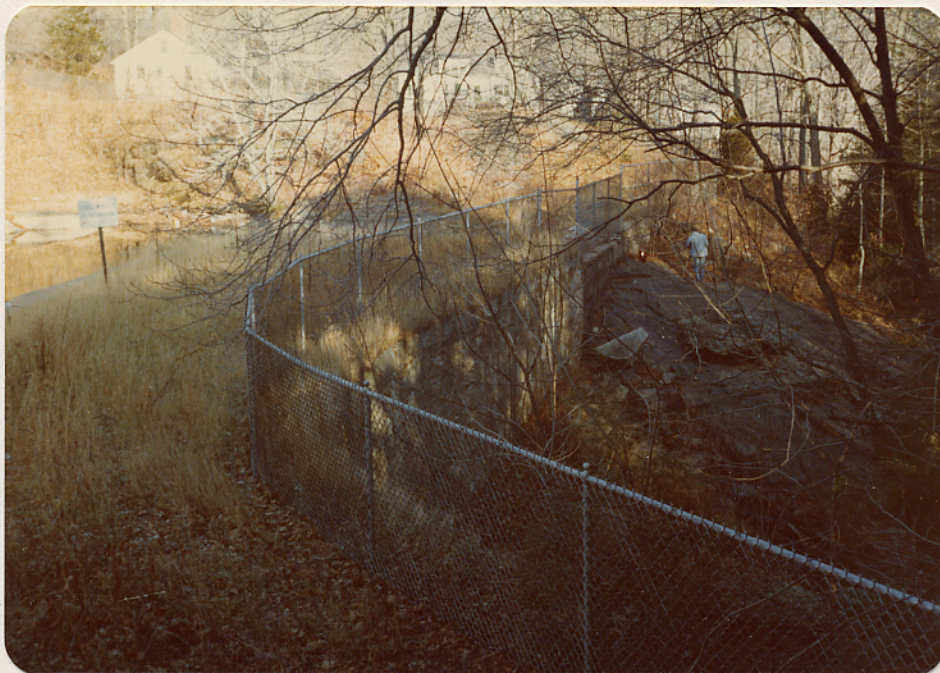
Crest - The crest of the dam is a grassed earth embankment which showed no signs of cracking or subsidence, as shown in Photo 5. A small sapling is growing on the dam crest near the right abutment just behind the downstream granite block retaining wall. A chain link fence runs along the crest of the dam and spillway approximately 3 feet upstream of the granite block wall.

PHOTO NO.5 - Looking to the left from right abutment showing dam crest, downstream face of dam, and natural rock spillway channel.

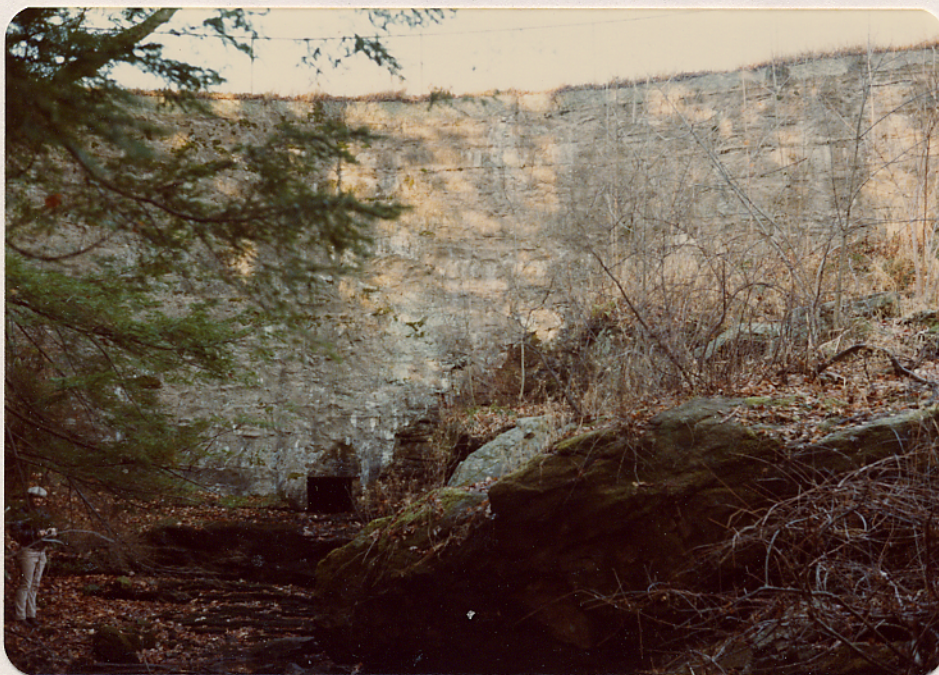
Downstream Face - The downstream face is a near-vertical granite block wall, partially arched in the area of the low level outlet as shown in Photo 6. Areas of the downstream face are covered with a thin layer of concrete facing as can be seen in Photo 2. With the exception of below the spillway crest, the downstream face is generally in good condition with only 2 small seeps observed. One was several feet above and to the left of the outlet channel. The other seep was a few feet below the top of the dam, immediately to the right of the spillway section. The flow of water was very small and was observed coming out from between stone blocks where mortar was partially or totally absent. No evidence of soil transport was observed.

PHOTO NO.6 - Downstream face of dam, low level outlet, and natural rock outlet channel.
